TECHNICAL COMMITTEE REPORT TCR 17/01

Technical report on Aldery Cliff bolt belay anchors

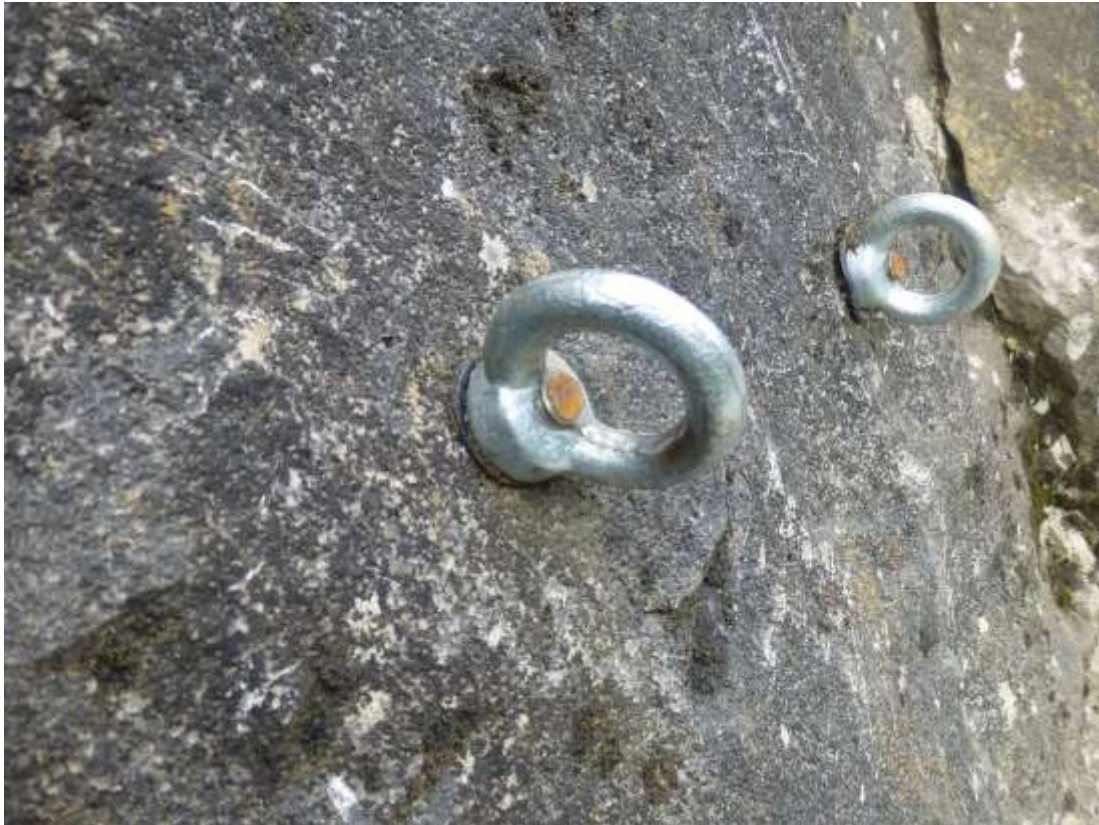
The second pair of anchors inspected are shown in the front cover photo. Both were fairly solid, with some form of rubber washer between the rock and the eyebolt. Again, the eyebolts were unmarked except for the thread size, and note the angle of the nearest eyebolt which is out of line of the anticipated load direction. Rust is already apparent on the surface of the threaded rod.

The main issue is the use of components of unknown provenance and capability. Lack of any markings to indicate the SWL, and the possibility of mixed materials being used (which will cause accelerated corrosion and weakening) mean that the safety and quality of the components used is questionable.

Eyebolts are reliably used in the construction industry when used with a setting tool to ensure that the eyebolt is aligned with the direction of loading. This isn't the case here – rotational forces will cause the eyebolts to come loose as has happened to at least one already. This indicates that the installer has not thought through the consequences of their choice of components fully.

BMC guidance to bolt installers gives AISI304 stainless steel as the minimum for outdoor use, which these hangers don't appear to meet. As such, these anchors don't meet BMC recommendations in terms of corrosion resistance.

These anchors should have the eyebolts removed to prevent any further use, and if possible the threaded rods should be hammered or cut flush – failing that flattening the threads will suffice to prevent further use.
